■ Gecking the Drive Gain Wear

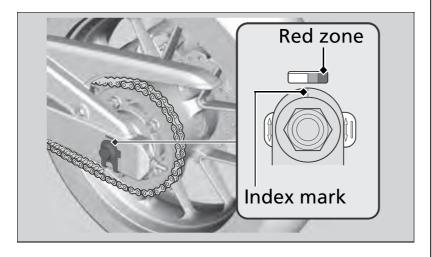
Check the chain wear label when adjusting the drive chain. If the index mark on the washer enters the red zone on the label after the chain has been adjusted to the proper slack, the chain is excessively worn and must be replaced.

Chain: DID 520V0

If necessary have the drive chain replaced by your dealer.

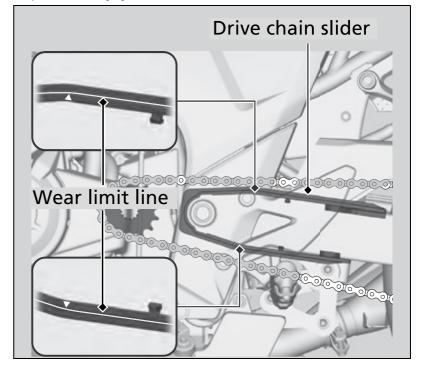
Checking the Drive Chain Slider

Check the condition of the drive chain slider. The drive chain slider need to be replaced if it is worn to the wear limit line.

If necessary have the drive chain slider replaced by your dealer.
