Checking the Drive Chain Wear

Checking the Drive Chain Slider

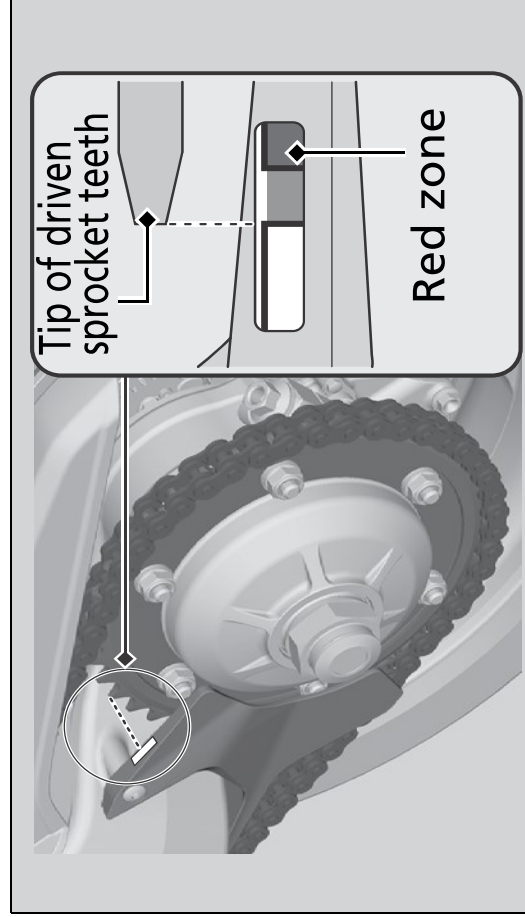
Check the chain wear label when adjusting the drive chain. If the red zone on the label aligns with the tip of driven sprocket teeth after the chain has been adjusted to the proper slack, the chain is excessively worn and must be replaced.

Chain:

DID 525HV3 or RK 525ROZ6

If necessary have the drive chain replaced by your dealer.

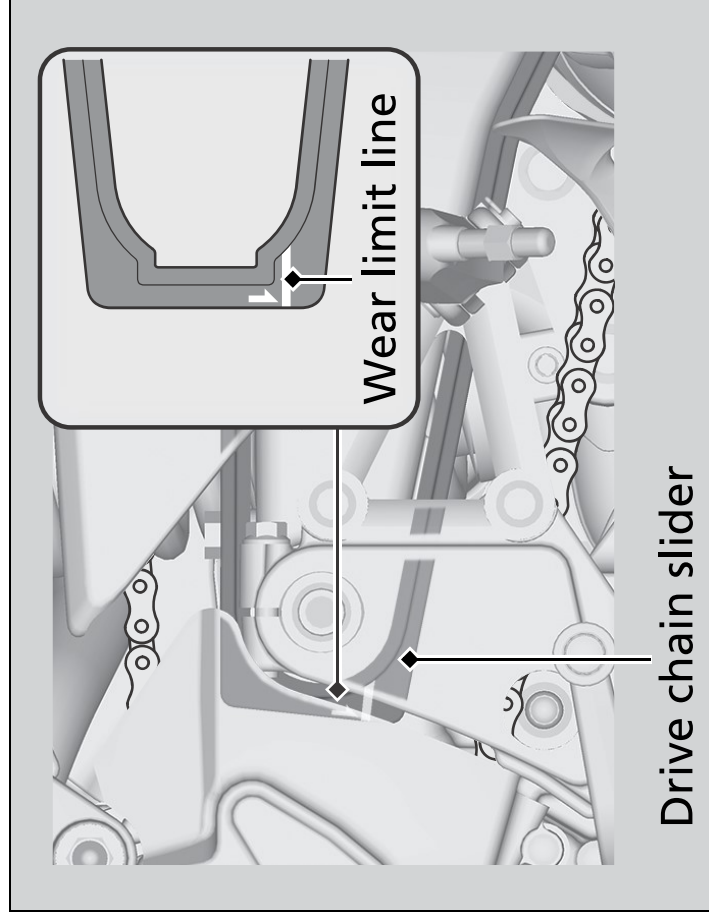
Check the condition of the drive chain slider. The drive chain slider need to be replaced if it is worn to the wear limit line. If necessary have the drive chain slider replaced by your dealer.
