Electrical servicing

Chapter lights / instruments / switches (ED/2ED)

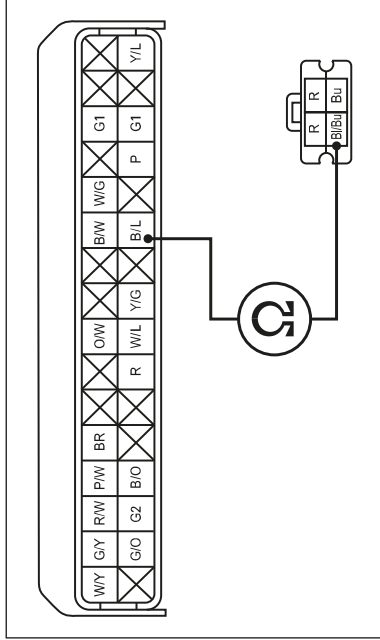
Wire harness inspection

Check for continuity of the Black/Blue wire between the fan motor relay 2P (Natural) connector and ECM 32P (Black) connector.
There should be continuity.
If there is no continuity, repair or replace the wire harness.
