## Inspecting the Brake Shoe Wear (VT750C2/C2F/C2B)

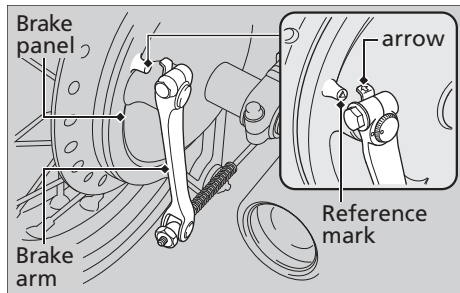
The rear brake is equipped with a brake wear indicator.

When the brake is applied, an arrow attached to the brake arm moves toward a reference mark on the brake panel. If the arrow aligns with the reference mark on full application of the brake, the brake shoes must be replaced.
