## ■ Checking the Drive Chain Wear

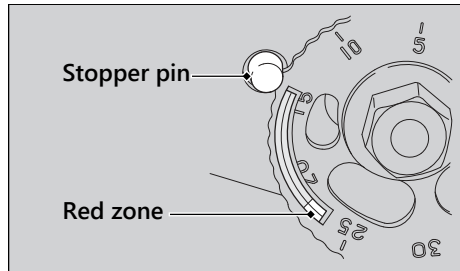
Check the chain wear label when adjusting the drive chain. If the stopper pin on the swingarm enters the red zone on the label after the chain has been adjusted to the proper slack, the chain is excessively worn and must be replaced.

**Chain:** RK 520MOZ6 or DID 520V8
